Monitoring Data Record

Project Title: U-2524AC (Greensboro Western Urban Loop) COE Action ID: 200321137

Stream Name: Long Branch (Site 2BA) DWQ Number: 030909

Year 4 Winter – January 2011

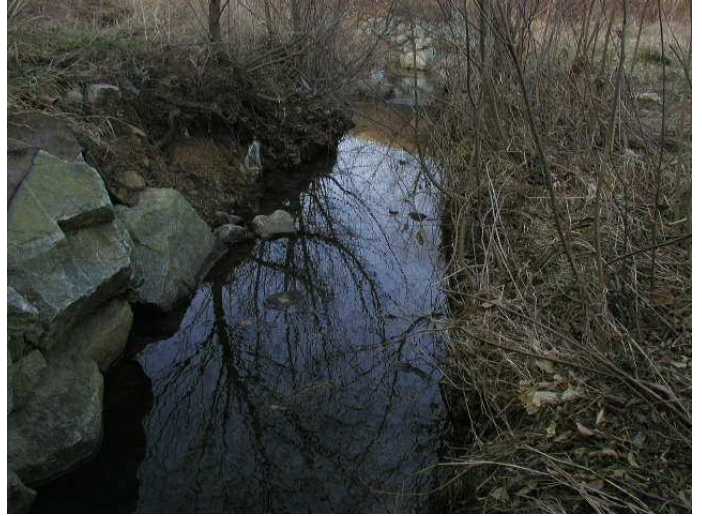
Photo Point #1 (Downstream)

1/24/11	Sta. 11+50 PP#1 Downstream Photo	Sta. 17+50 Additional Photo	Sta. 20+00 PP#5 Downstream Photo	Sta. 23+00 Additional Photo	Sta. 27+00 PP#9 Upstream and Downstream Photo
Structure Type					
Is water piping through or around structure?					
Head cut or down cut present?					
Bank or scour erosion present?	Minor bank scouring on left bank downstream of boulder protection	Minor bank scouring on right bank	Minor bank scouring on left bank downstream of boulder protection	Minor bank scouring on left bank downstream of boulder protection	Minor bank scouring on right and left bank

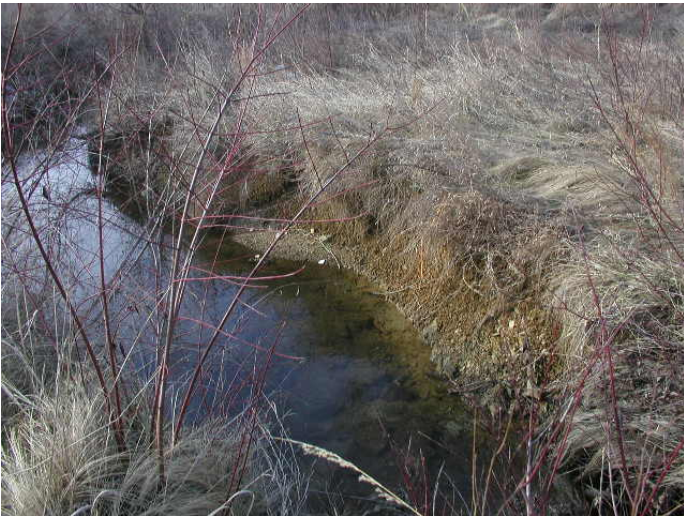
The Long Branch stream relocation is stable for the Year 4 Winter evaluation, except for, some minor bank scouring that still exist with little or no change since the last evaluation at the station numbers noted below. NCDOT will continue to monitor this stream relocation.

Bank Scouring @ Sta. 17+50

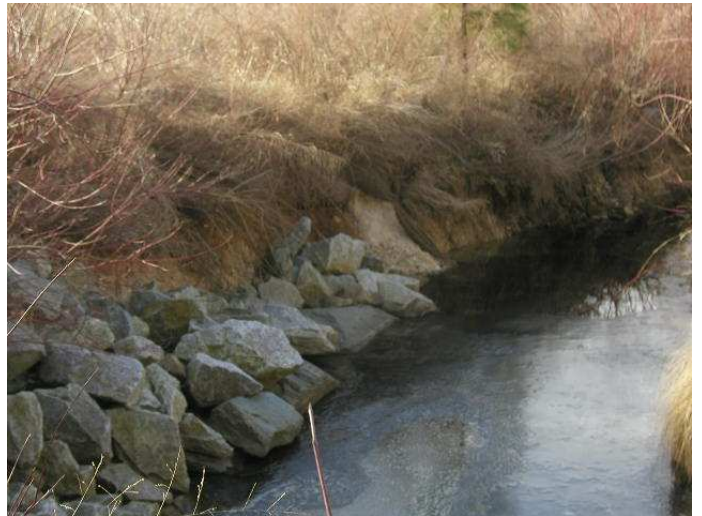
Bank Scouring @ Sta. 23+00 on Left Bank
